REDFIELD SITE
DENVER, COLORADO

MAXIMUM PREMITIGATION INDOOR AIR TEST RESULTS AS OF JUNE 30, 2007 (GROUNDWATER SOURCE)

PLATE #2 SEPT 2007
 BG-0280 JCG

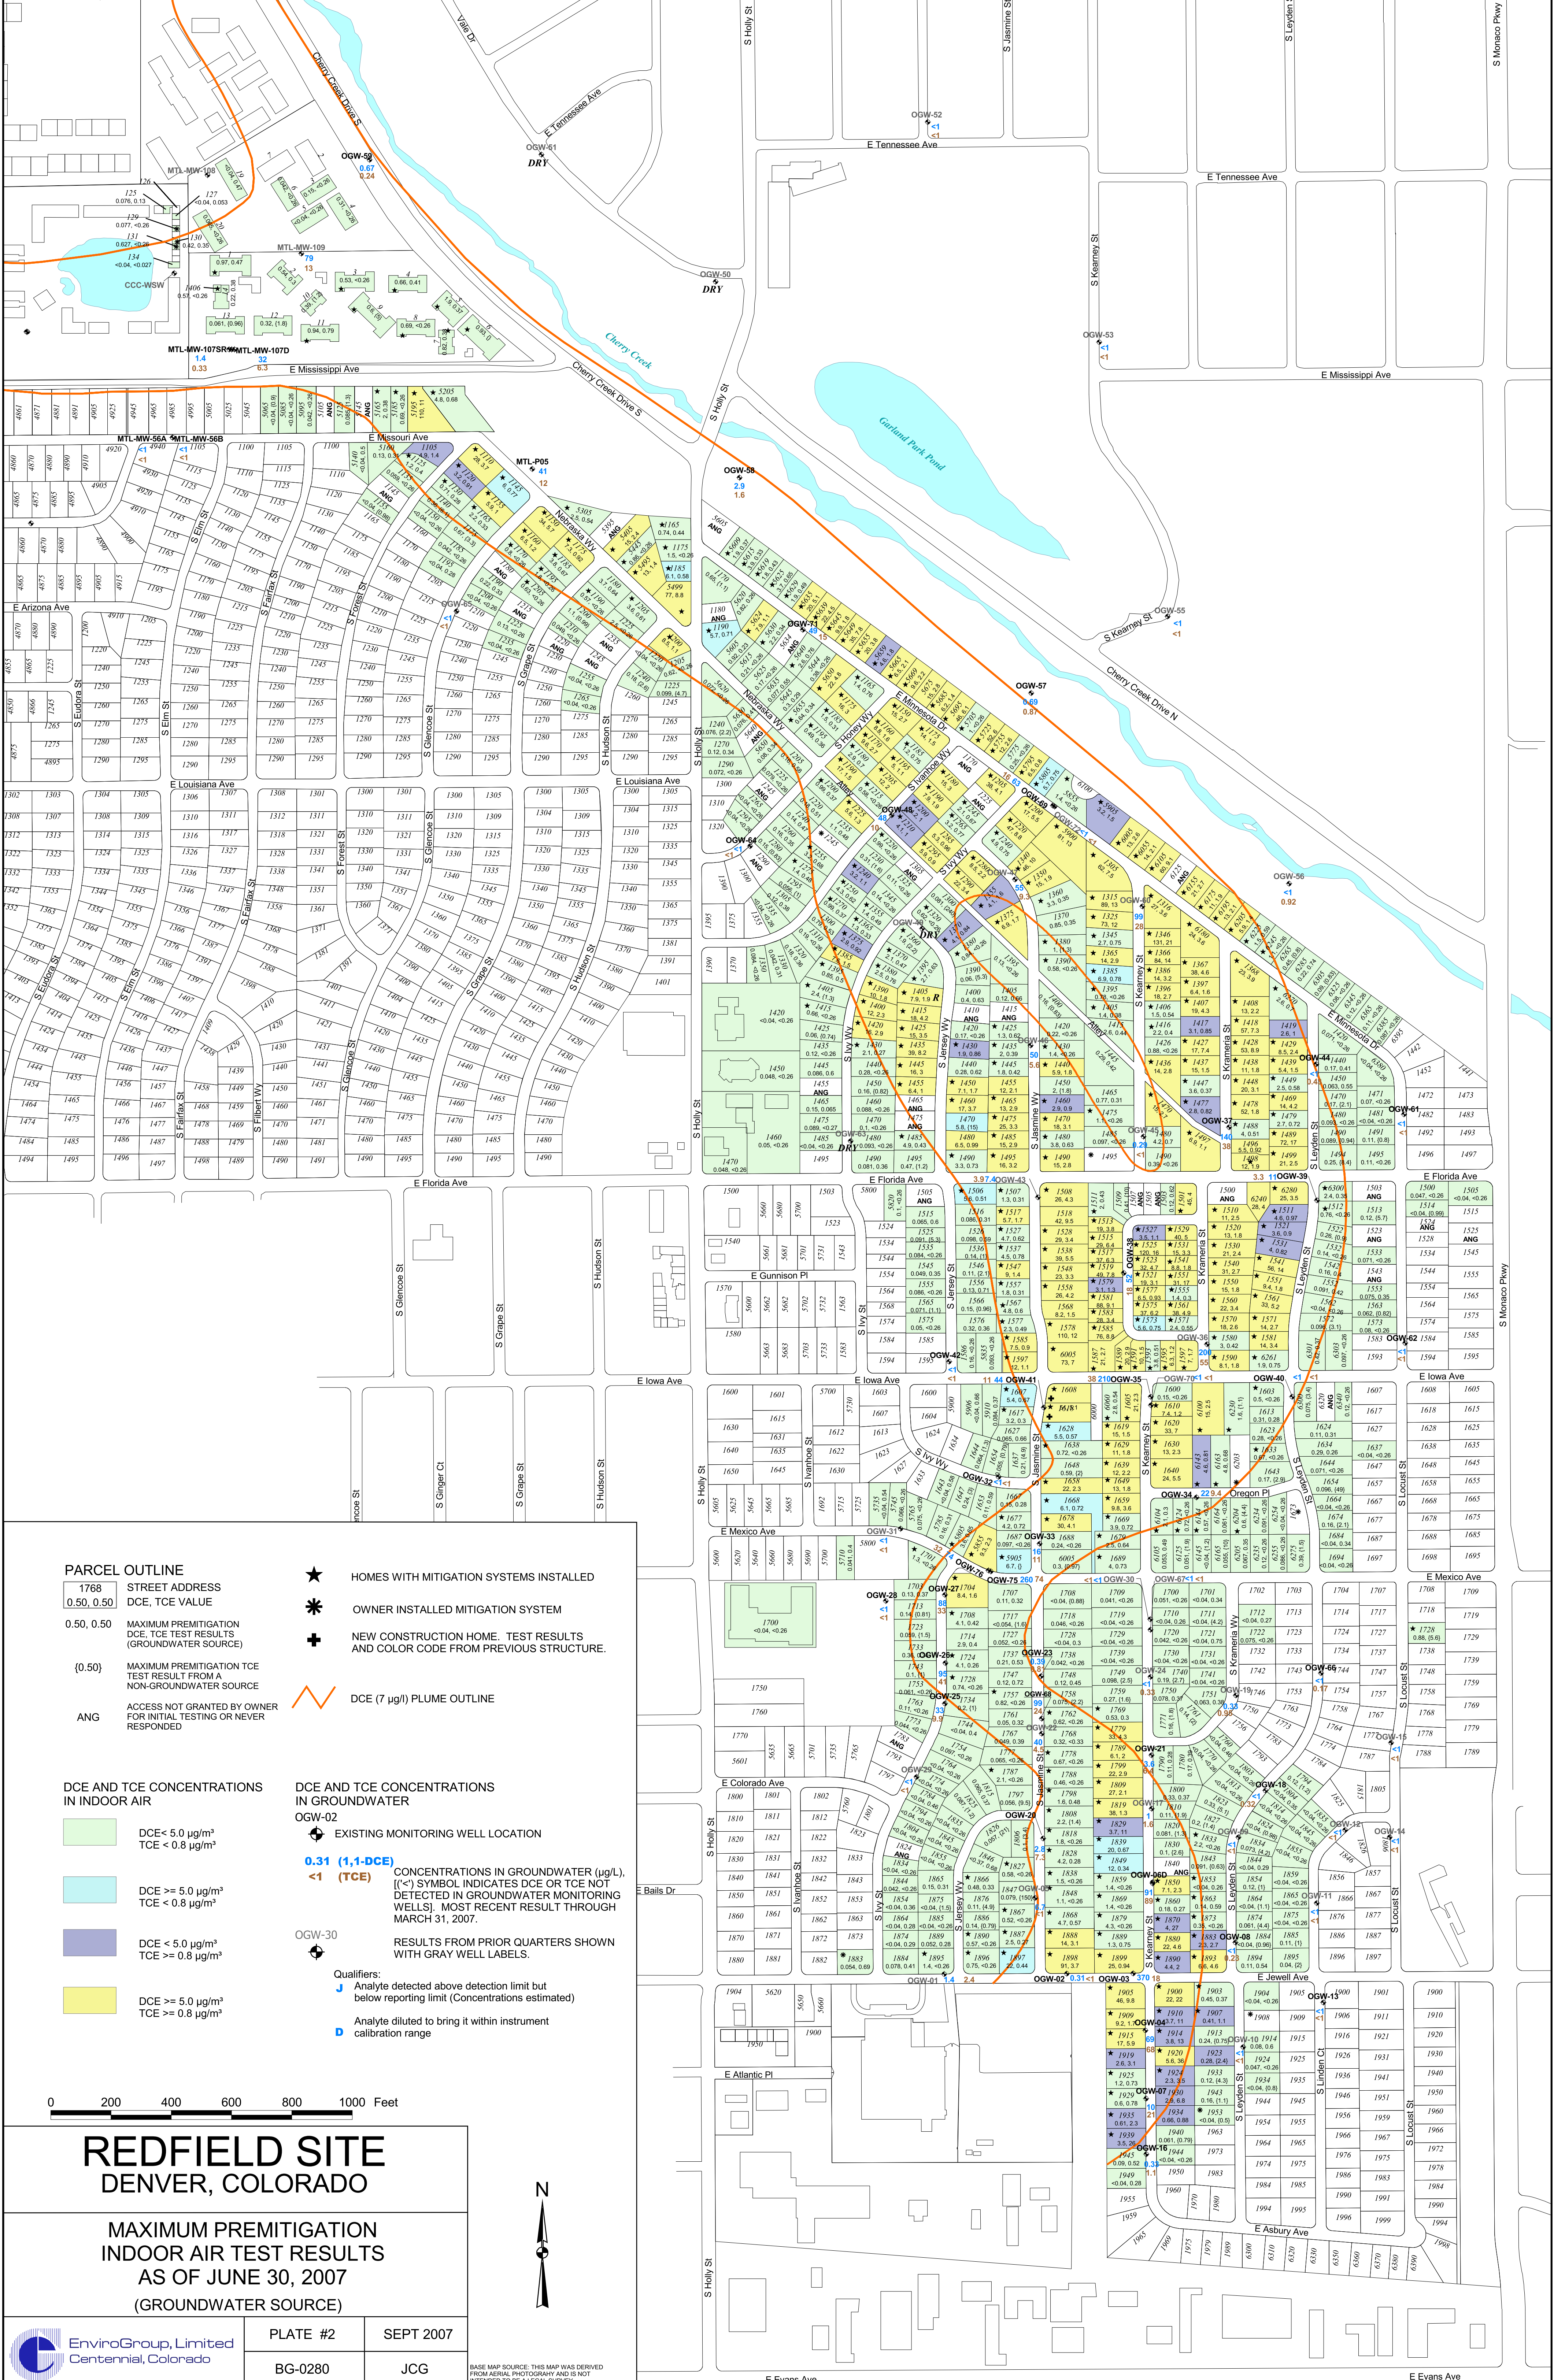
DCE AND TCE CONCENTRATIONS IN INDOOR AIR
 DCE < 5.0 µg/m³
 TCE < 0.8 µg/m³
 DCE ≥ 5.0 µg/m³
 TCE < 0.8 µg/m³
 DCE < 5.0 µg/m³
 TCE ≥ 0.8 µg/m³
 DCE ≥ 5.0 µg/m³
 TCE ≥ 0.8 µg/m³

DCE AND TCE CONCENTRATIONS IN GROUNDWATER
 OGW-02 EXISTING MONITORING WELL LOCATION
 0.31 (1,1-DCE) <1 (TCE) CONCENTRATIONS IN GROUNDWATER (µg/L). (*) SYMBOL INDICATES DCE OR TCE NOT DETECTED IN GROUNDWATER MONITORING WELLS. MOST RECENT RESULT THROUGH MARCH 31, 2007.
 OGW-30 RESULTS FROM PRIOR QUARTERS SHOWN WITH GRAY WELL LABELS.
 Qualifiers:
 J Analyte detected above detection limit but below reporting limit (Concentrations estimated)
 D Analyte diluted to bring it within instrument calibration range
